# Injection Molded Rollers

## Preliminary Testing Data and Approval

The aim of this report is to evaluate the suitability of injection molded rollers manufactured by Diversified Plastics for use in our supply chain, specifically on our 4-wheel rollers. The report is based on a field study conducted in the United States. The study examined the performance of five different roller configurations and a Control configuration, which uses machined UHMW rollers and represents our current production model. The data was collected over a period of 77,846 cars that were washed after the installation of the injection molded rollers on September 15th, 2022. An illustration of the different roller configurations is shown below. This report will provide information and recommendations on the implementation of the injection-molded rollers into our production process based on the findings and conclusions drawn from the study.

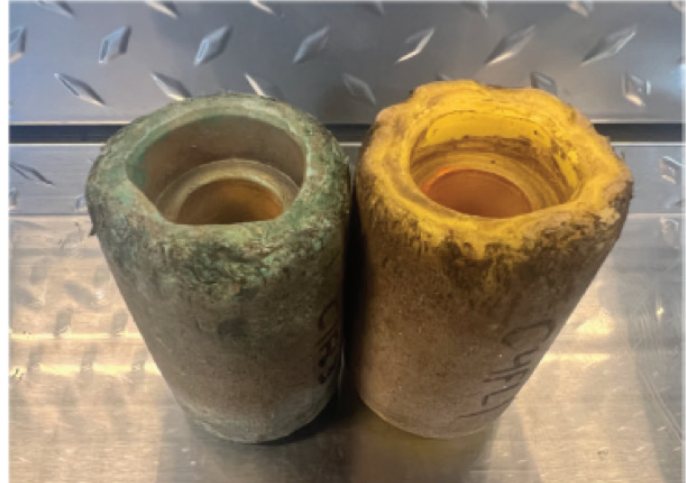
In the first image, we can see deformations on the outside of the counterbore of the pusher rollers. These deformations are caused by the reduced wall diameter thickness at that location, which is consistent between both types of rollers. However, it's important to note that we checked and verified the smooth operation of the rollers before disassembly, and we found that these deformations do not affect their functionality in any way.

In addition, the physical observations of the rollers, such as the deformations at the outside of the counterbore and the material removal on the counterbore side of the outside diameter, do not impact the rollers' ability to function as intended. We also found that the material removed from the roller was chipped away instead of peeled away, indicating uniformity in the material and production process.

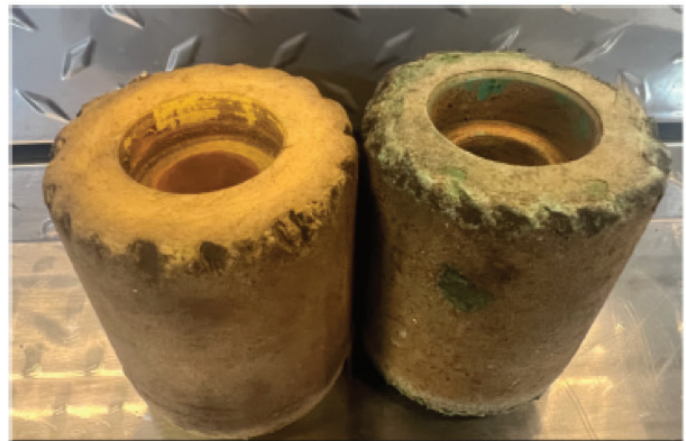
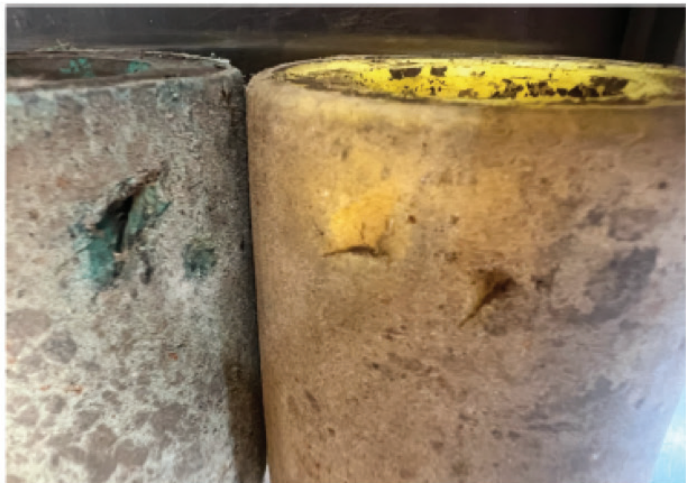
The second image shows material removal and "gnawing" on the counterbore side of the outside diameter. This type of damage is usually caused by physical contact between the roller assembly and a component on the conveyor assembly. However, what's important to note is that there is no delamination or large separation on the roller, and the material that was removed is chipped away instead of peeling away. This indicates uniformity in the material and production process, which is a positive indicator of the quality of both types of rollers.

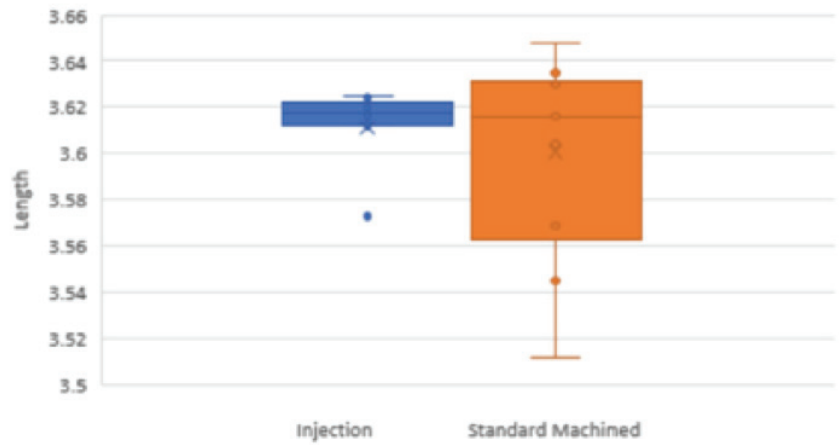
**Back Left Large Roller - Length**

The Back-Left and Back-Right rollers bear the primary load of the roller on the conveyor's top deck. We found that the length measurements for the injection molded rollers were much more consistent than those of the machined rollers, with a smaller deviation from the average.

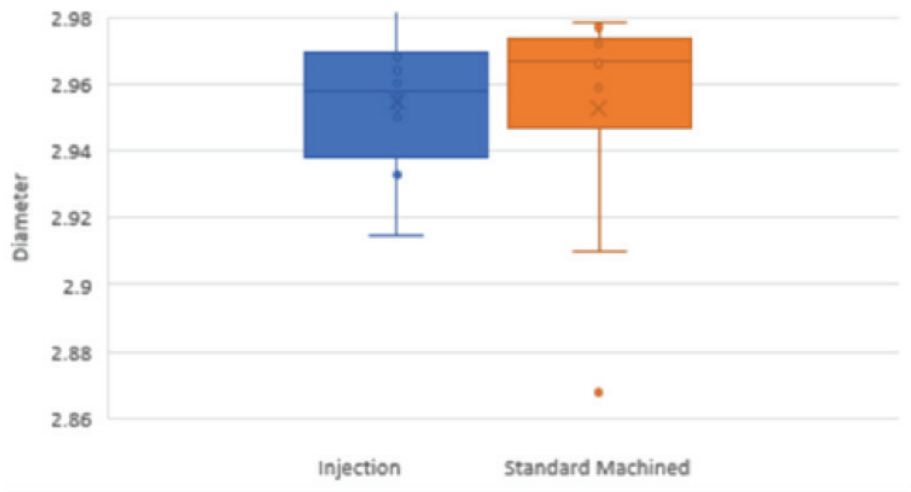
**Back Left Large Roller - Length**

The outside diameter measurements for the Back-Left and Back-Right rollers were very similar. Both groups had comparable overall deviations from the average and wear. There were a few outliers for both types of rollers, but this was expected given the harsh environment they are exposed to. It's worth noting that an "outlier" in this graph represents additional wear of approximately 1/32".

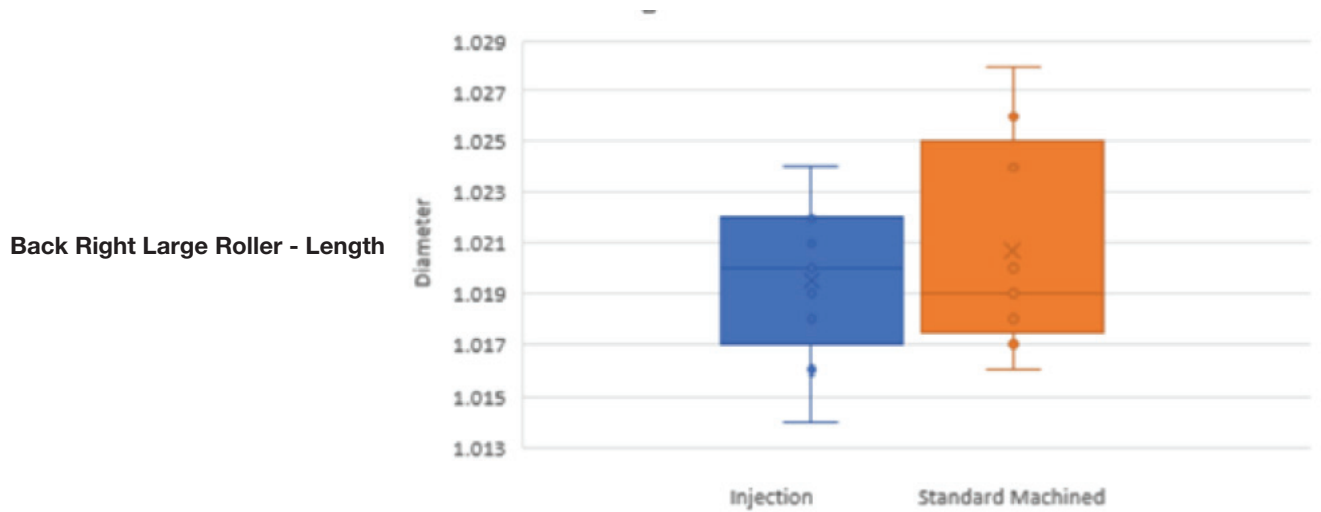
The following graph shows the internal bore diameter of the drive rollers, a critical dimension because an increase in bore diameter can cause the roller to shift on the pin of the roller frame. Additionally, excessive wear on the internal bore of the roller has been known to cause increased washer wear which results in premature failure of the entire roller assembly. The wear for both the injection molded and machined rollers was comparable, with differences within a few thousandths of an inch. The injection molded rollers exhibited less wear on the internal bore than the machined UHMW counterpart on average. It's worth noting that the right roller exhibited slightly more wear than the left roller, which is expected because the rollers tend to shift towards the right side of the conveyor during operation.

Based on the analysis of the data collected from the testing setup, it can be concluded that the quality of the injection molded rollers is comparable to the machined UHMW rollers for the large roller. The outside diameter measurements of the Back-Left and Back-Right rollers were found to be very similar, with both groups having comparable overall deviations from the average and wear. The internal bore diameter of the drive rollers was also comparable, with differences within a few thousandths of an inch. The rollers were found to be within acceptable tolerances of expected wear in both scenarios and there is no evidence to suggest that they would fail prematurely.
